# **BEXHILL-ON-SEA TOWN COUNCIL**

## **Sidley House, Allotments Fencing Report**

### **February 2024**

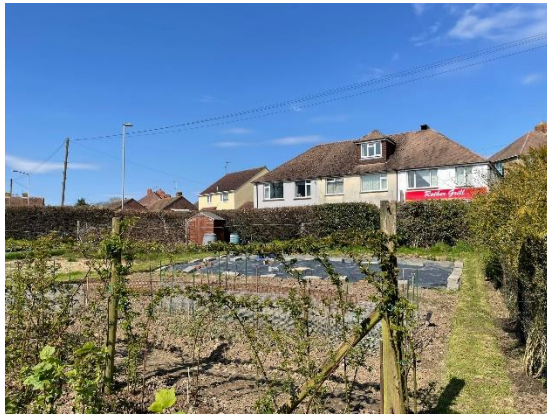
**Location:** Ninfield Roadside

**Description:** There is a conifers hedge all along this side. It is 2 meters in height. The Condition currently is that there are several holes in sections where animals and trespassers are getting in and rubbish is being thrown over.

It is recommended to install a six-foot chain-link fence inside the boundary of the allotment to deter animals and trespassers from getting in. Regular maintenance should also be scheduled to ensure ongoing durability.

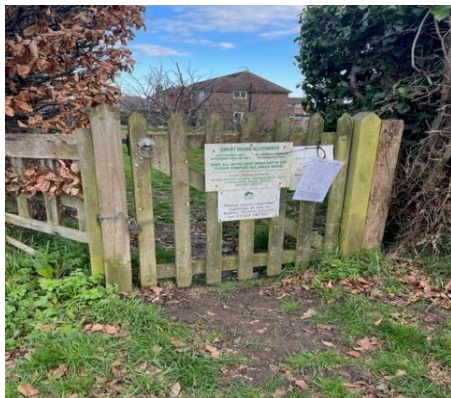
**Location:** Ninfield /Turkey Roadside

The Entrance gate to the allotments is worn and low, being held with a makeshift chain and lock. It is easy to jump over and trespasses have gotten in.

It is recommended to consider installing lockable taller 6ft gates at the entrances to ensure only authorised individuals and plot holders have access.

The faded sign on the gate should be replaced and display Bexhill Town Council contact information for the allotment management or relevant authorities in case of emergencies.

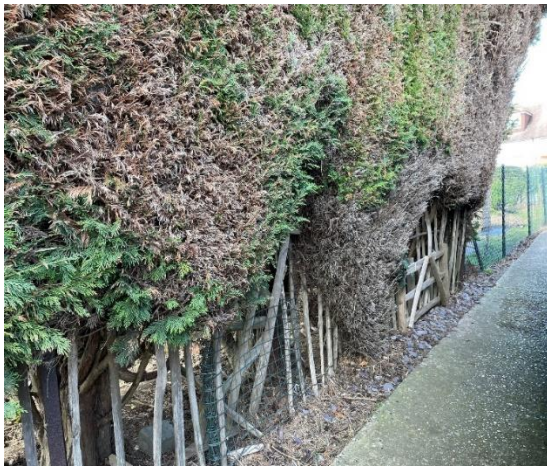
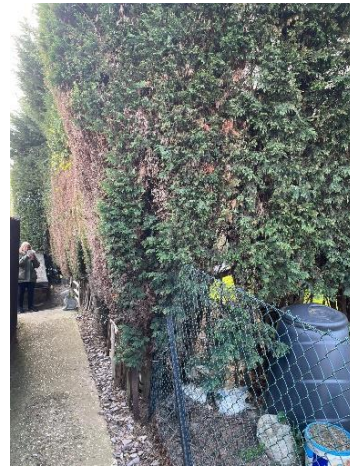
**Location:** Sidley Roadside

There are Hedges all along this side of conifers as well as a chain link, chicken wire and wooden fencing. It is 2 meters in height. The Condition currently is that there are several

holes in sections, with damaged or deteriorated wooden fencing and fencing where animals and trespasses are getting in.

The overgrown hedges have been trimmed to give access to residents who live next door.

It is recommended to consider installing 6ft Chain link fence with sturdy posts all along

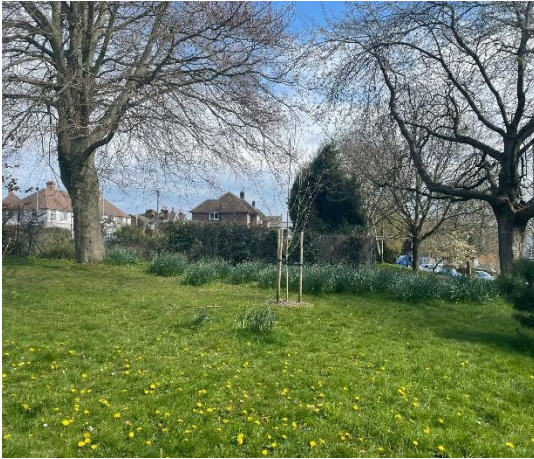
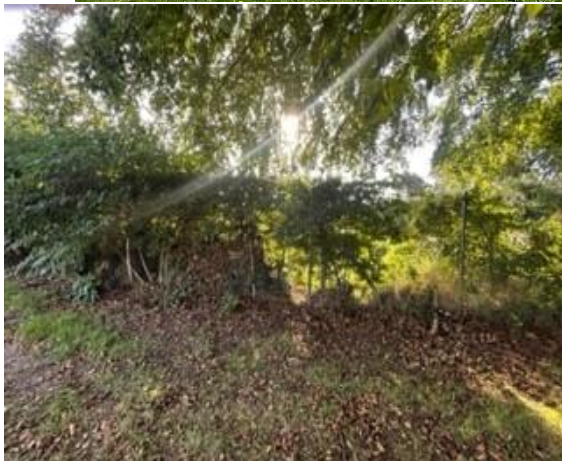
**Location:** Turkey Road, Roadside

There are Hedges all along this side of conifers as well as a chain link fence. It is 2 meters in height. The Condition currently is that there are several holes in sections where animals and trespasses are getting in. There are overgrown weeds and vegetation along the inside of the hedges. There is a build-up of allotment waste that was promised to be removed by the previous Council.

It is recommended to install a six-foot chain-link fence inside the boundary of the allotment to deter animals and trespassers from getting in. Regular maintenance should also be scheduled to ensure ongoing durability.

Arrange removal of Waste.

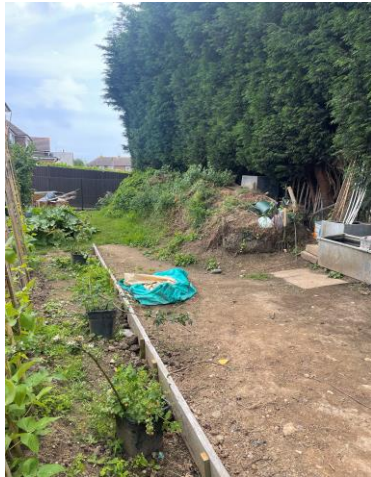
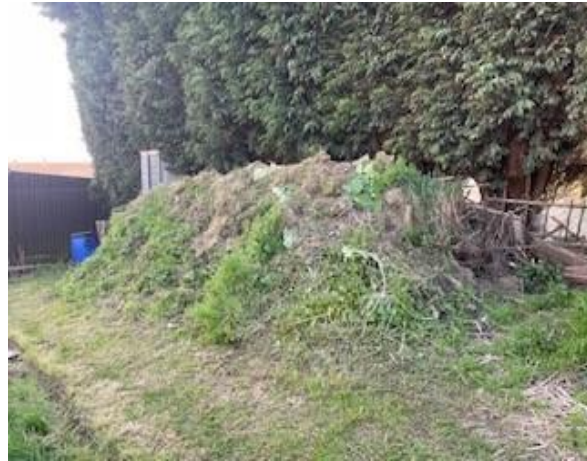
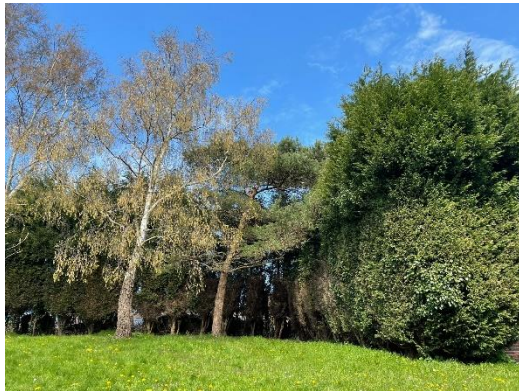
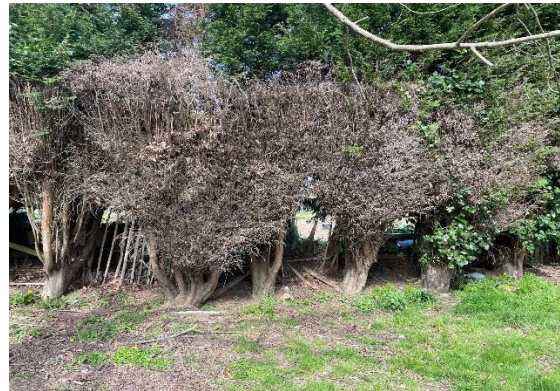
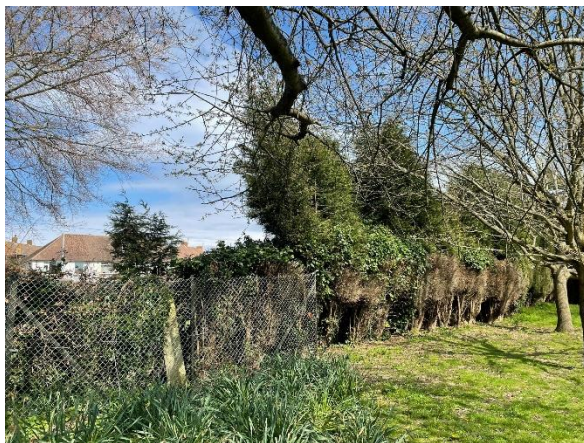
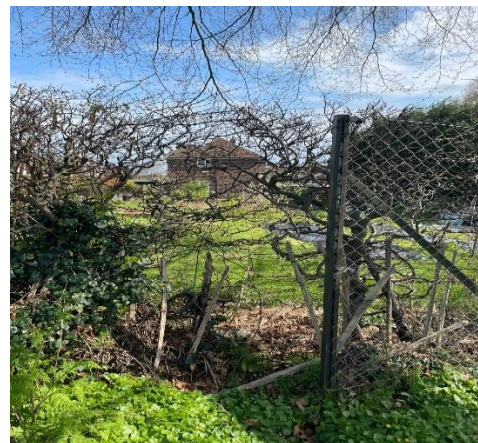
**Location:** Turkey Road, Roadside

There is large trees and conifers alongside this section. They were very overgrown and have been trimmed recently. There is on the outside of the trees a small section that has a chain link fence. It is 2 meters in height. In between the conifer trees, there are large holes where animals and trespasses are getting in creating security concerns and compromising the overall integrity of the perimeter. Break-ins have occurred and Plot holders have made temporary barriers to stop trespasses coming in but they are being taken down.

There is two large mounds of waste mud built up , this soil cannot be used on the allotment plots there has been rat infestation, Badgers, foxes, and moles burrowing. It will need to be removed from the plot. It is close to the trees and it will be difficult to put the fencing up without removing them.

Considering the extent of the damage to the allotment plots due to security being compromised, it is recommended to put 6ft chain fencing in this area inside the boundary area in front of the trees. The new fence should be of sturdy material, capable of withstanding external forces, and provide better security.

The two waste soil mounds will need to be removed to allow space to put the fence up and all vegetation growth along there removed and kept maintained.
