# **BEXHILL-ON-SEA TOWN COUNCIL**

## **Sidley House, Allotments Fencing Report**

### **February 2024**

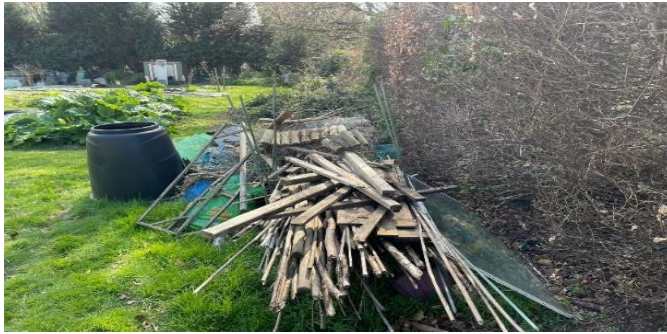
### **3.1 Compromised Area 5:**

**Location:** Turkey Road, Roadside

Considering the extent of the damage to the allotment plots due to security being compromised, it is recommended to put 6ft chain fencing in this area inside the boundary area in front of the trees. The new fence should be of sturdy material, capable of withstanding external forces, and provide better security.
